**Flood Control Project Maintenance  
Levee Inspections**  
**LMA District Cover Sheet**  
**Spring 2018 Levee Inspection Results**

**Reclamation District No. 0341 Sherman Island**

**Spring 2018 Levee Inspection Results**

**Levee Inspection Report By Mile - Spring 2018**

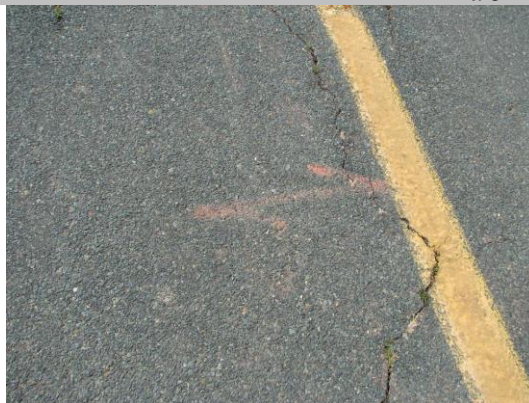
Photo 1 of 3 : UCIP\_SP\_2018\_52253\_37647.jpg

Underground Service Alert (USA) markings on road surface indicating line is still present.

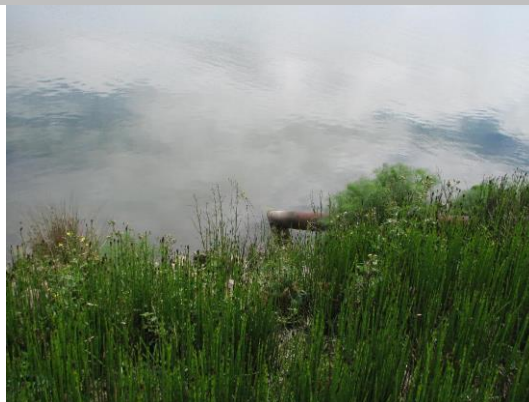
Photo 2 of 3 : UCIP\_SP\_2018\_52254\_37658.jpg

Pipe visible from WS.

Comment Code						
Inspector Comment						
FS_ID:52254 DS_ID:24111 EP_NO: 1477 Repair Type: Non-Urgent Crossing Status: Found UCIP Comments: 07/06/2016 According to LMA Superintendent, Joel McElroy, the LS pipe section was replaced in about 2005 under the Three Mile Slough Project. No work was completed on crown or WS. (DWR UCIP - O. Magana) 05/05/2009 Dense vegetation limits the inspector's visibility to identify signs of pipe failure (leaks) along the slopes. Recommend removing vegetation along pipe alignment to conduct proper inspection of structure and appurtenances. (DWR UCIP - O. Magana) FIELD_STRUCT_DESC: 10-inch steel irrigation siphon pipe through the levee, 1.8 feet below the crown. 10-inch pipe is encased in 12-inch corrugated metal conduit under crown. Pump is located on landside (LS). Air vent and metal distribution box with gate are located on the LS. Rock revetment placed along the waterside (WS) slope. A 30-foot section of pipe under the crown was replaced and encased in corrugated metal pipe (CMP) under unknown permit. (10-inch pipe authorized under Permit No. 1477, 1950 - L. J. Anderson) [Additional Reference(s): DWR Levee Log, 1992. USACE Sacramento O&M Manual Unit No. 101, February 1962, (HLM 0.50). LMA encroachment station (STA) reference based on Map of Evacuation Route, Reclamation District 341 Sherman Island by Wagner Bonsignore Consulting Civil Engineers, A Corporation dated July 2012, STA 149+00] FS Date: 5/5/2009

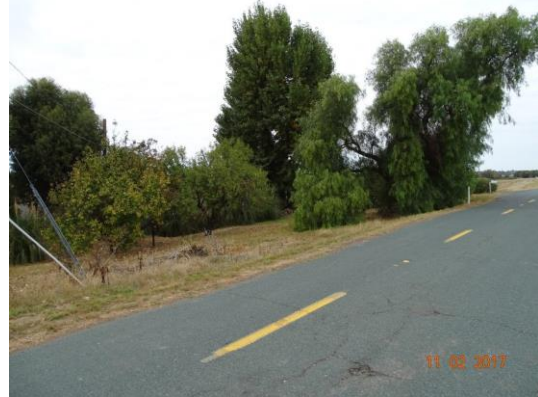
Photo 1 of 1 : SP\_2018\_RD0341\_167\_20\_20180305\_00001.jpg

LM Start	0.76	Rating **	M	Issue No.	20
LM End	0.76	Issue Type +	En	Location *	LS
Category	Earthen Levee			GPS Latitude/Longitude	
				Start	End
Item	Vegetation			38.096477 °	38.096477 °
				-121.686908 °	-121.686908 °
DWR ID	DWR_RD0341_01_f_2017_20				
Comment Code					
V6 : Landscaping					
Inspector Comment					
Landscaping should be reduced and maintained.

Large willow tree and pampas grass partially blocks visibility and access to landside slope and toe. This landscaping should be trimmed/thinned.

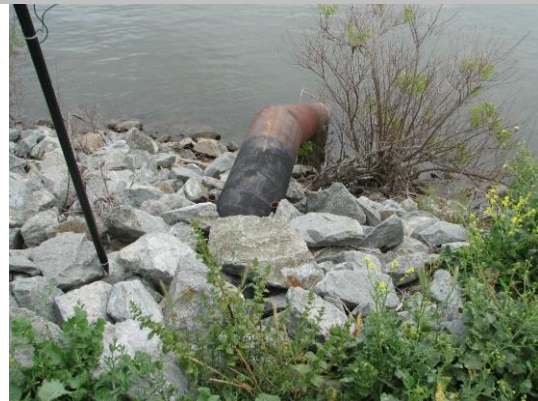
Photo 1 of 3 : UCIP\_SP\_2018\_52255\_37664.jpg

Comment Code					
Inspector Comment					
FS_ID:52255 DS_ID:24113 EP_NO: 11095 Repair Type: Non-Urgent Crossing Status: Found UCIP Comments: 07/06/2016 According to LMA Superintendent, Joel McElroy, this pipe is an irrigation siphon pipe and not a drainage pipe. Primer stem and primer is located on the LS near the berry shrubs. (DWR UCIP - O. Magana) 05/05/2009 Dense vegetation limits the inspector's visibility to identify signs of pipe failure (leaks) along the slope. Recommend removing vegetation along pipe alignment to conduct proper inspection of structure and appurtenances. (DWR UCIP - O. Magana) FIELD_STRUCT_DESC: 18-inch steel irrigation siphon pipe sleeved through 24-inch pipe through the levee, 4 feet below the crown. Primer stem and primer located on the landside (LS). Pipe exposed on the waterside (WS) slope. (18-inch pipe authorized under Automatic Board Order (ABO) issued as Permit No. 11095, 1975 - A. M. Cabral). [Additional Reference(s): DWR Levee Log, 1992. LMA encroachment station (STA) reference based on Map of Evacuation Route, Reclamation District 341 Sherman Island by Wagner Bonsignore Consulting Civil Engineers, A Corporation dated July 2012, STA 118+00] FS Date: 5/5/2009

View of pipe located on WS.

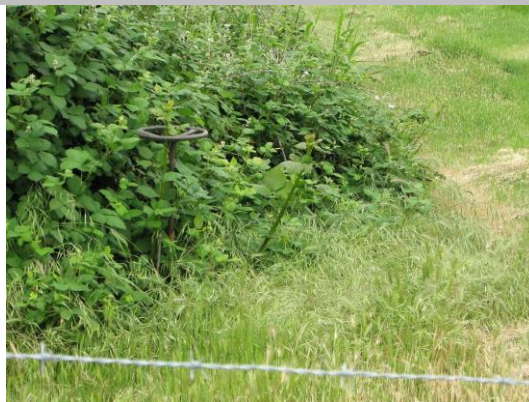
Photo 3 of 3 : UCIP\_SP\_2018\_52255\_37662.jpg

Gate located past the fence area near LS toe.

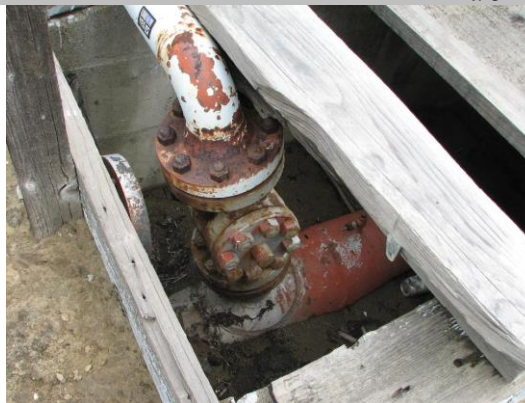
Photo 3 of 3 : UCIP\_SP\_2018\_52257\_37679.jpg

View of pipe inside concrete box located on LS.

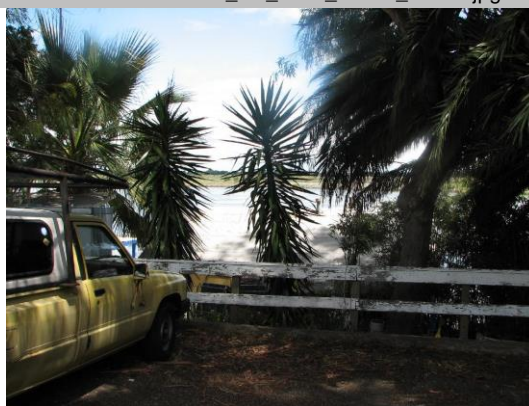
Photo 1 of 3 : UCIP\_SP\_2018\_52258\_37706.jpg

Comment Code					
Inspector Comment					
FS_ID:52258 DS_ID:24116 EP_NO: 11103 Repair Type: Non-Urgent Crossing Status: Found UCIP Comments: 05/05/2009 Unable to determine if crossing is the same as permitted under permit no. 11103. Need to contact owner and determine status of crossing under permit no. 11103. Believe steel conduit is exposed on landward side. (DWR UCIP - O. Magana) FIELD_STRUCT_DESC: 1.5-inch iron water pipe and 3.5-inch electrical steel conduit through the levee, both 3 feet below the crown. Pressure system and service pole located on the landside (LS) slope. Fishing resort located on the waterside (WS). (1.5-inch pipe authorized under Automatic Board Order (ABO) issued as Permit No. 11103, 1975 - Western Water Ways, Inc.; 3.5-inch not listed in Permit No. 11103) [Additional Reference(s): DWR Levee Log, 1992. LMA encroachment station (STA) reference based on Map of Evacuation Route, Reclamation District 341 Sherman Island by Wagner Bonsignore Consulting Civil Engineers, A Corporation dated July 2012, STA 71+00] FS Date: 5/5/2009

View of WS.

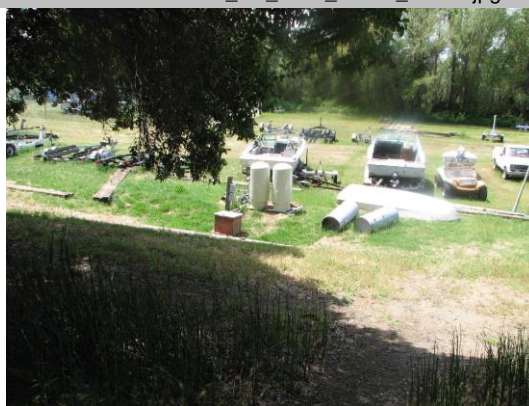
Photo 3 of 3 : UCIP\_SP\_2018\_52258\_37703.jpg

View of LS.

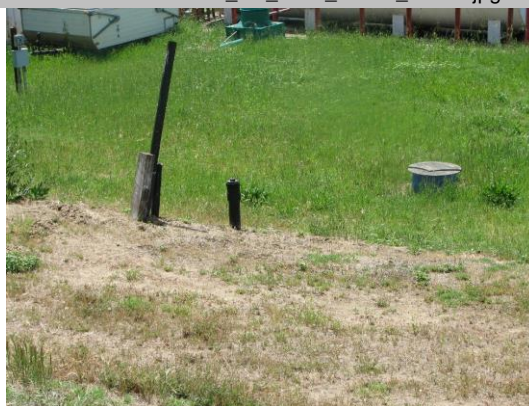
Photo 1 of 3 : UCIP\_SP\_2018\_52259\_37712.jpg

Comment Code					
Inspector Comment					
FS_ID:52259 DS_ID:24117 EP_NO: 5427 Repair Type: Non-Urgent Crossing Status: Indicator Found UCIP Comments: 07/06/2016 According to LMA Superintendent, Joel McElroy, the features on the LS include sump pump inside well and drain leach field. The septic line pumps from WS to LS and deposit water in hole. (DWR UCIP - O. Magana) 05/05/2009 Unable to find pipe or sump pump. Indicators found on landward side include potential septic tank and observation well. Need to contact owner of crossing to determine status of crossing. (DWR UCIP - O. Magana) FIELD_STRUCT_DESC: 1 of 2: 4-inch galvanized iron sewage pipe sleeved through 6-inch steel pipe through the levee, 3.7 feet below the crown. Sump pump located on the waterside (WS) slope. Septic tank and observation well are located on the landside (LS). (4-inch pipe authorized under Permit No. 5427, 1966 - Patrick's Resort) [Additional Reference(s): DWR Levee Log, 1992. LMA encroachment station (STA) reference based on Map of Evacuation Route, Reclamation District 341 Sherman Island by Wagner Bonsignore Consulting Civil Engineers, A Corporation dated July 2012, STA 69+00] FS Date: 5/5/2009

View of potential observation well on LS.

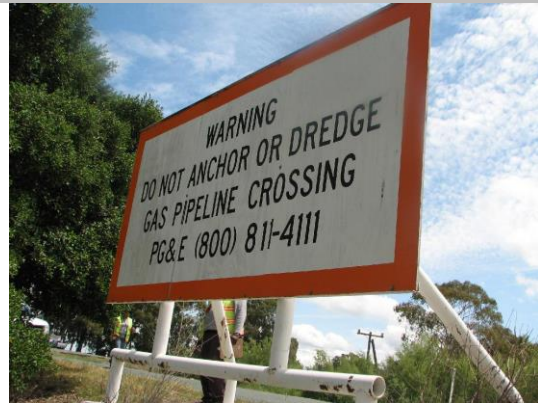
Photo 1 of 2 : UCIP\_SP\_2018\_52261\_37719.jpg

Pipeline marker located on WS shoulder.

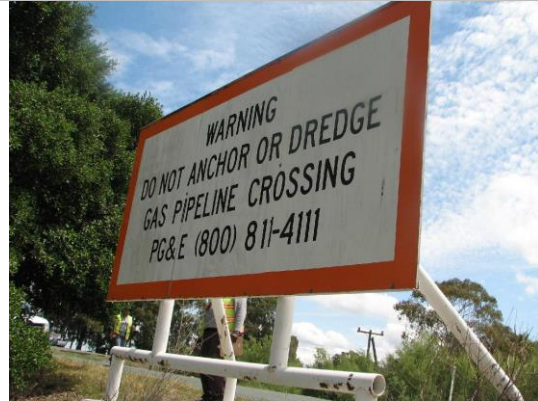
Photo 1 of 2 : UCIP\_SP\_2018\_52263\_71847.jpg

Comment Code						
Inspector Comment						
FS_ID:52263 DS_ID:24756 EP_NO: 17251 Repair Type: Non-Urgent Crossing Status: Indicator Found UCIP Comments: 03/04/2014 Need to contact owner to determine status of crossing. Need date of last inspection and confirmation that crossing is still in operable condition. (DWR UCIP - O. Magana) FIELD_STRUCT_DESC: 24-inch steel natural gas line through the levee, 125-feet below the levee crown (24-inch pipe authorized under Permit No. 17251 and 17251-Rev, 2002 - Lodi Gas Storage, LLC). [Additional Reference(s): LMA encroachment station (STA) reference based on Map of Evacuation Route, Reclamation District 341 Sherman Island by Wagner Bonsignore Consulting Civil Engineers, A Corporation dated July 2012, STA 64+00] FS Date: 3/4/2014

View of sign located on WS.

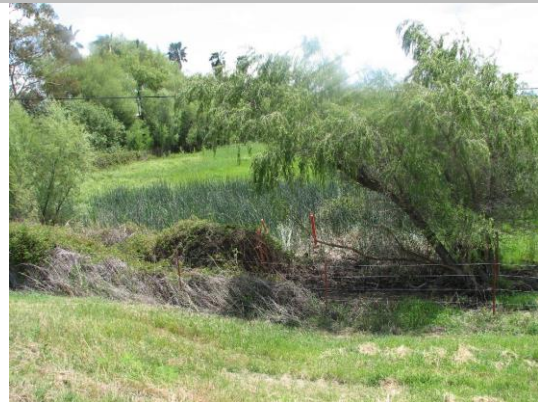
Photo 2 of 2 : UCIP\_SP\_2018\_52263\_71846.jpg

Markers visible on LS toe.

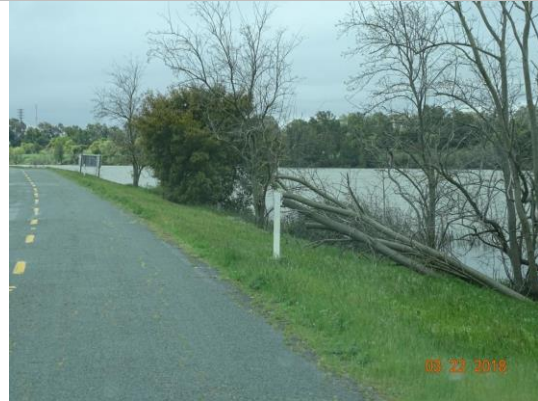
Photo 1 of 1 : SP\_2018\_RD0341\_167\_21\_20180322\_00052.jpg

LM Start	2.19	Rating **	M	Issue No.	21
LM End	2.19	Issue Type +	Ma	Location *	WS
Category	Earthen Levee			GPS Latitude/Longitude	
				Start	End
Item	Encroachments			38.113144 °	38.113144 °
				-121.687601 °	-121.687601 °
DWR ID	DWR_RD0341_01_s_2018_21				
Comment Code					
TR : Tree or limb					
Inspector Comment					
Remove fallen tree on waterside slope.

Fallen tree on waterside slope should be removed.

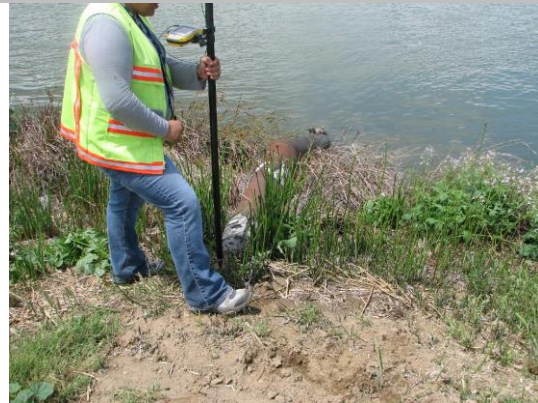
Photo 1 of 3 : UCIP\_SP\_2018\_52264\_37734.jpg

Comment Code						
Inspector Comment						
FS_ID:52264 DS_ID:24120 EP_NO: 11102 Repair Type: Non-Urgent Crossing Status: Found UCIP Comments: 07/06/2016 According to LMA Superintendent, Joel McElroy, the LS pipe was repaired/repaired under the Three Mile Slough Project in 2005, Setback Project, Project covers Station 10+00 to 175+00. (DWR UCIP - O. Magana) 05/05/2009 Dense vegetation limits the inspector's visibility to identify signs of pipe failure (leaks) along the slope. Recommend removing vegetation along pipe alignment to conduct proper inspection of structure and appurtenances. (DWR UCIP - O. Magana) FIELD_STRUCT_DESC: 10-inch steel irrigation pipe sleeved through a 12-inch pipe through the levee, 4.6 feet below the levee crown. Annular gap grouted between pipes. Irrigation canal with distribution box located on the landside (LS) toe. Rock revetment is located on the waterside (WS) slope. (10-inch pipe authorized under Automatic Board Order (ABO) issued as Permit No. 11102, 1975 - C. and E. Silva) [Additional Reference(s): DWR Levee Log, 1992. USACE Sacramento O&M Manual Unit No. 101, February 1962 (HLM 2.33). LMA encroachment station (STA) reference based on Map of Evacuation Route, Reclamation District 341 Sherman Island by Wagner Bonsignore Consulting Civil Engineers, A Corporation dated July 2012, STA 51+00] FS Date: 5/5/2009

View of pipe on WS.

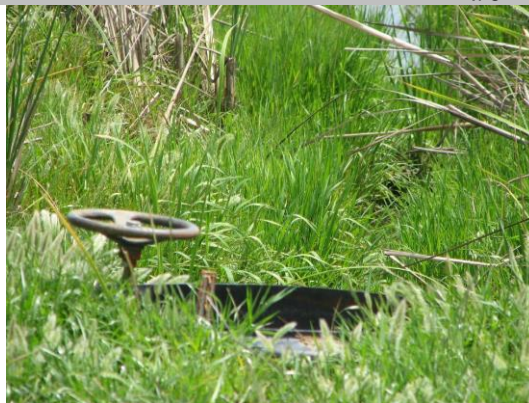
Photo 2 of 3 : UCIP\_SP\_2018\_52264\_37733.jpg

Riser and gate visible on LS--dense vegetation limits inspection.

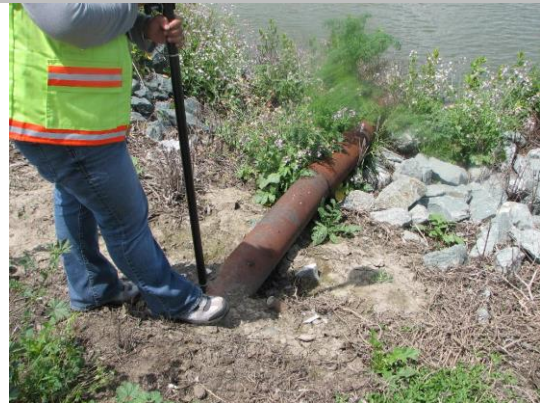
Photo 1 of 3 : UCIP\_SP\_2018\_52265\_37750.jpg

View of pipe and rip rap located on WS.

FS\_ID:52265  
DS\_ID:24121  
EP\_NO: N/A  
Repair Type: Non-Urgent  
Crossing Status: Found  
UCIP Comments: 07/06/2016 According to LMA Superintendent, Joel McElroy, the LS pipe was repaired/repared under the Three Mile Slough Project in 2005, Setback Project, Project covers Station 10+00 to 175+00. (DWR UCIP - O. Magana)  
05/05/2009 Pipe size does not match -- found 10 inch instead of 8 inch. Pipe (1 of 2) was supposed to be removed and replaced with 12-inch steel irrigation pipes under Permit No. 5629 (1966). Historical Levee Logs from 1992 do not reflect that the replacement was completed, verify diameter of pipes and status with applicant. Dense vegetation limits the inspector's visibility to identify signs of pipe failure (leaks) along the slope. Recommend removing vegetation along pipe alignment to conduct proper inspection of structure and appurtenances. (DWR UCIP - O. Magana)  
FIELD\_STRUCT\_DESC: 1 of 2: 10-inch (not 8-inch as originally noted in records) steel irrigation pipe through the levee, 1.4 feet below the crown. Siphon breaker is located on the landside (LS). Irrigation ditch with distribution box is located on LS toe. Pipe exposed on both slopes. Rock revetment present along on waterside (WS) slope. [Additional Reference(s): DWR Levee Log, 1992. USACE Sacramento O&M Manual Unit No. 101, February 1962 (HLM 2.93), two 8-inch pipes. LMA encroachment station (STA) reference based on Map of Evacuation Route, Reclamation District 341 Sherman Island by Wagner Bonsignore Consulting Civil Engineers, A Corporation dated July 2012, STA 20+00]

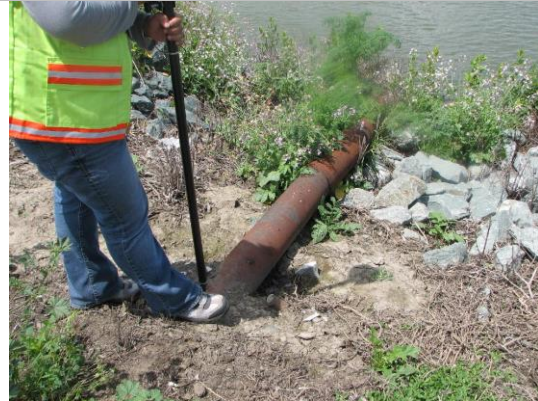
Photo 1 of 3 : UCIP\_SP\_2018\_52266\_37758.jpg

FIELD\_STRUCT\_DESC: 2 of 2: 10-inch (not 8-inch as originally mentioned in desk study) steel irrigation pipe through the levee, 1.6 feet below the crown. Siphon breaker located on the landside (LS). Irrigation ditch with distribution box located on the LS toe. Pipe exposed on both slopes. Rock revetment placed on waterside (WS) slope. [Additional Reference(s): DWR Levee Log, 1992. USACE Sacramento O&M Manual Unit No. 101, February 1962 (HLM 2.93), two 8-inch pipes. LMA encroachment station (STA) reference based on Map of Evacuation Route, Reclamation District 341 Sherman Island by Wagner Bonsignore Consulting Civil Engineers, A Corporation dated July 2012, STA 20+00]  
FS Date: 5/5/2009

View of pipe and rip rap located on WS.

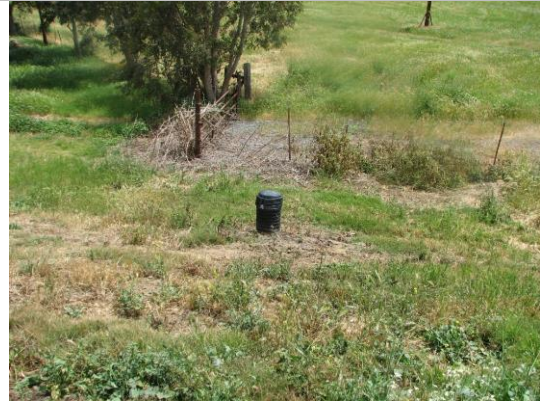
Photo 3 of 3 : UCIP\_SP\_2018\_52266\_37756.jpg

View of LS slope - stand pipe not associated with crossing.

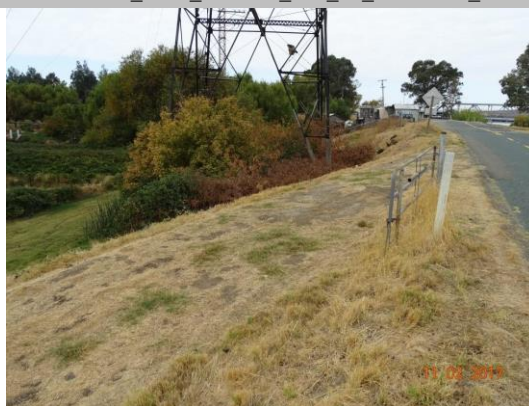
Photo 1 of 1 : SP\_2018\_RD0341\_167\_22\_20180305\_00002.jpg

LM Start	3.21	Rating **	M	Issue No.	22
LM End	3.21	Issue Type +	Ma	Location *	LS
Category	Earthen Levee			GPS Latitude/Longitude	
				Start	End
Item	Vegetation			38.104677 °	38.104677 °
				-121.700030 °	-121.700030 °
DWR ID	DWR_RD0341_01_f_2017_22				
Comment Code					
V2 : Remove the wild growth other than native grasses from the levee slopes.					
Inspector Comment

Remove or thin wild vegetation at base of electrical transmission tower to allow visibility and access to slope and toe.

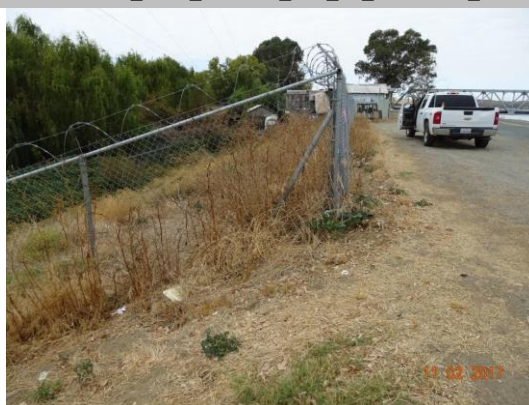
Photo 1 of 1 : SP\_2018\_RD0341\_167\_23\_20180305\_00003.jpg

LM Start	3.24	Rating **	U	Issue No.	23
LM End	3.24	Issue Type +	En	Location *	LS
Category	Earthen Levee			GPS Latitude/Longitude	
				Start	End
Item	Encroachments			38.104834 °	38.104834 °
				-121.700479 °	-121.700479 °
DWR ID	DWR_RD0341_01_f_2017_23				
Comment Code					
FE : Fence					
Inspector Comment					
Unpermitted chan link and barbed wire fence enclosure prevents inspection and access to landside of levee.

Unpermitted fence.

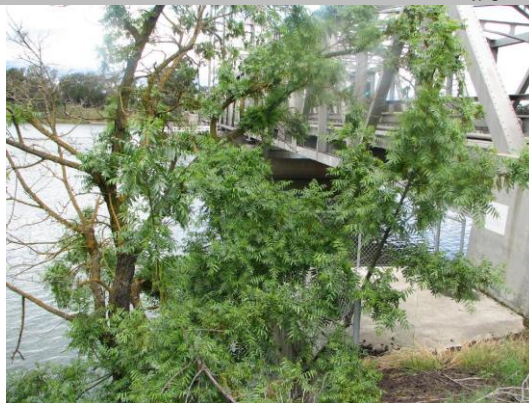
Photo 1 of 3 : UCIP\_SP\_2018\_52267\_37780.jpg

View of WS.

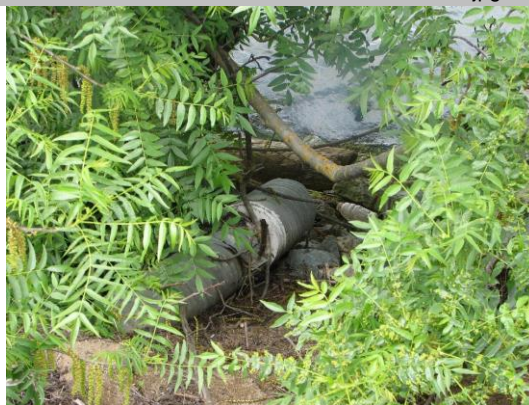
Photo 2 of 3 : UCIP\_SP\_2018\_52267\_37783.jpg

Pipe visible on the WS.

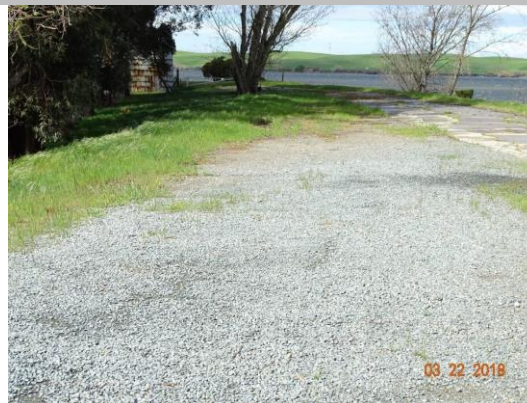
Photo 1 of 1 : SP\_2018\_RD0341\_168\_36\_20180322\_00085.jpg

LM Start	3.36	Rating **	A/W	Issue No.	36
LM End	3.94	Issue Type +	Ma	Location *	LS
Category	Earthen Levee			GPS Latitude/Longitude	
				Start	End
Item	Vegetation			38.105315 °	38.098158 °
				-121.702537 °	-121.706320 °
DWR ID	DWR_RD0341_02_s_2017_36				
Comment Code					
V2 : Remove the wild growth other than native grasses from the levee slopes.					
Inspector Comment					
Weeds have been reduced to an acceptable level in this area.

Acceptable landside vegetation.

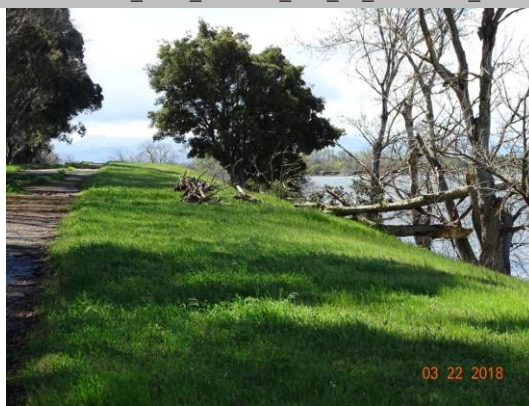
Photo 1 of 1 : SP\_2018\_RD0341\_168\_44\_20180322\_00086.jpg

LM Start	3.48	Rating **	M	Issue No.	44
LM End	3.48	Issue Type +	Ma	Location *	WS
Category	Earthen Levee			GPS Latitude/Longitude	
				Start	End
Item	Encroachments			38.104454 °	38.104454 °
				-121.704275 °	-121.704275 °
DWR ID	DWR_RD0341_02_s_2018_44				
Comment Code					
TR : Tree or limb					
Inspector Comment					
Remove tree limbs from waterside shoulder.

Tree limbs on waterside shoulder should be removed.

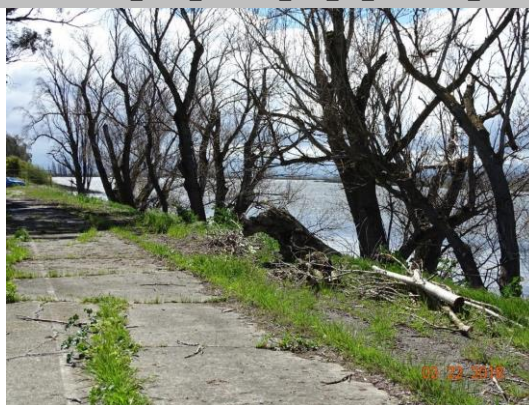
Photo 1 of 1 : SP\_2018\_RD0341\_168\_46\_20180322\_00087.jpg

LM Start	3.88	Rating **	M	Issue No.	46
LM End	3.88	Issue Type +	Ma	Location *	WS
Category	Earthen Levee			GPS Latitude/Longitude	
				Start	End
Item	Encroachments			38.099054 °	38.099054 °
				-121.706368 °	-121.706368 °
DWR ID	DWR_RD0341_02_s_2018_46				
Comment Code					
TR : Tree or limb					
Inspector Comment					
Remove tree and limbs from waterside shoulder.

Tree trunk and limbs should be removed from waterside shoulder.

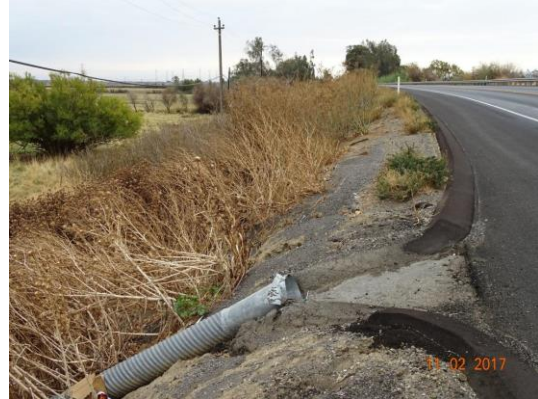
Photo 1 of 1 : SP\_2018\_RD0341\_168\_43\_20180305\_00013.jpg

LM Start	3.97	Rating **	M	Issue No.	43
LM End	6.03	Issue Type +	Ma	Location *	LS
Category	Earthen Levee			GPS Latitude/Longitude	
				Start	End
Item	Vegetation			38.097782 °	38.080143 °
				-121.706262 °	-121.728330 °
DWR ID	DWR_RD0341_02_f_2017_43				
Comment Code					
V2 : Remove the wild growth other than native grasses from the levee slopes.					
Inspector Comment					
Remove the unwanted vegetation from the landside shoulder, slope and toe.

Remove the unwanted vegetation from the landside shoulder, slope and toe.

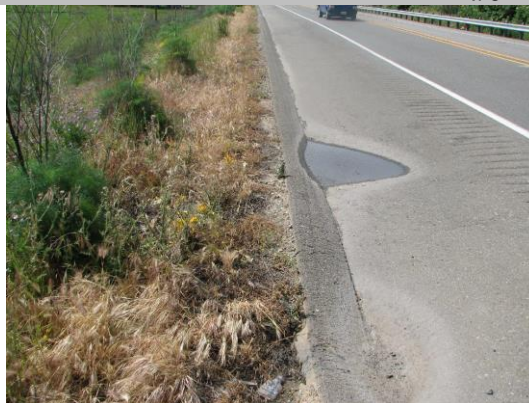
Photo 2 of 3 : UCIP\_SP\_2018\_22203\_37832.jpg

FS\_ID:22203  
DS\_ID:24135  
EP\_NO: 11110  
Repair Type: Non-Urgent  
Crossing Status: Found  
UCIP Comments: 07/06/2016 According to LMA Superintendent, Joel McElroy, DWR acquired land in 1995-2000 maybe earlier. Pipe is not used. Need to determine DWR Office is responsible for RD0341. Need to contact owner determine fate of crossing. (DWR UCIP - O. Magana) 05/06/2009 Need to determine status of crossing--need to contact owner. Dense vegetation limits the inspector's visibility to identify signs of pipe failure (leaks) along the slope. Recommend removing vegetation along pipe alignment to conduct proper inspection of structure and appurtenances. (DWR UCIP - O. Magana)  
FIELD\_STRUCT\_DESC: 10-inch steel irrigation pipe sleeved through 12-inch pipe through the levee, 3.8 feet below the crown. Pump on concrete well on landside (LS) slope. (10-inch pipe authorized under Automatic Board Order (ABO) issued as Permit No. 11110, 1975 - I. McKinnon, et al) [Additional Reference(s): DWR Levee Log, 1992. USACE Sacramento O&M Manual Unit No. 101, February 1962, (HLM 4.03). LMA encroachment station (STA) reference based on Map of Evacuation Route, Reclamation District 341 Sherman Island by Wagner Bonsignore Consulting Civil Engineers, A Corporation dated July 2012, STA 988+00]

View of landward shoulder and low spots on highway.

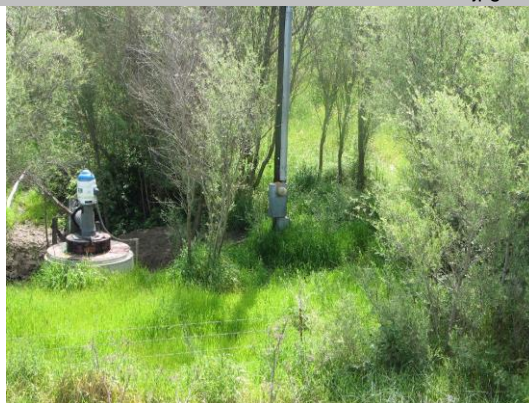
Photo 3 of 3 : UCIP\_SP\_2018\_22203\_37835.jpg

View of well and pump located on landward side.

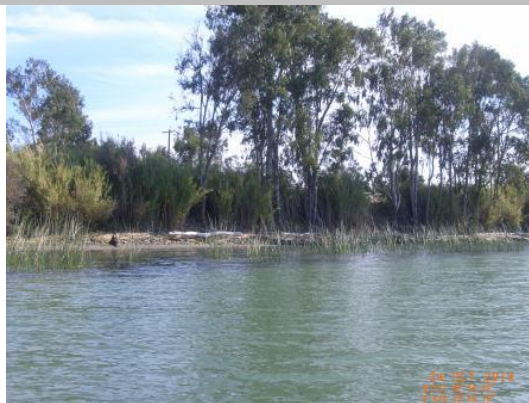
Photo 1 of 1 : SP\_2018\_RD0341\_168\_7\_20180305\_00004.jpg

LM Start	4.15	Rating **	M	Issue No.	7
LM End	4.19	Issue Type +	Ma	Location *	WS
Category	Supplemental			GPS Latitude/Longitude	
				Start	End
Item	2015 USACE Erosion Survey, DRAFT			38.095148 °	38.094590 °
				-121.706367 °	-121.706393 °
DWR ID	DWR_RD0341_02_s_2016_7				
Comment Code					
Inspector Comment					
2011 - Large new erosion pocket probably hidden by vegetation in the past. 2015: No observed changes. [2015 Site ID: SAC_8-2_L]

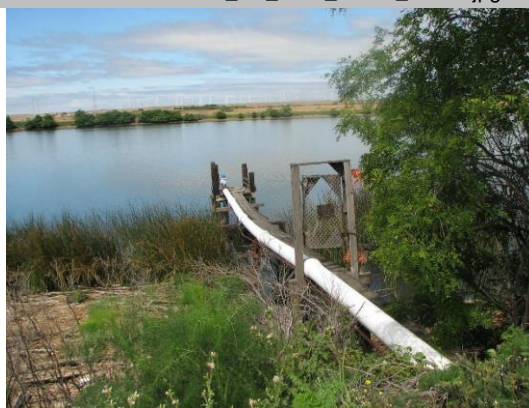
Photo 1 of 1 : UCIP\_SP\_2018\_22223\_37840.jpg

Comment Code						
Inspector Comment						
FS_ID:22223 DS_ID:24122 EP_NO: 11106 Repair Type: Non-Urgent Crossing Status: Found UCIP Comments: 07/06/2016 According to LMA Superintendent, Joel McElroy, DWR acquired land in 1995-2000 maybe earlier. Need to determine DWR Office is responsible for RD0341. Need to contact owner determine fate of crossing. (DWR UCIP - O. Magana) 05/06/2016 Need to contact owner to determine status of crossing. Dense vegetation limits the inspector's visibility to identify signs of pipe failure (leaks) along the slope. Recommend removing vegetation along pipe alignment to conduct proper inspection of structure and appurtenances. (DWR UCIP - O. Magana) FIELD_STRUCT_DESC: 12-inch pipe through the levee, 4 feet below the crown. Pump on pile structure in stream. (12-inch pipe authorized under Automatic Board Order (ABO) issued as Permit No. 11106, 1975 - A. and M. E. Cabral) [Additional Reference(s): DWR Levee Log, 1992. USACE Sacramento O&M Manual Unit No. 101, February 1962, (HLM 4.29). LMA encroachment station (STA) reference based on Map of Evacuation Route, Reclamation District 341 Sherman Island by Wagner Bonsignore Consulting Civil Engineers, A Corporation dated July 2012, STA 974+00] FS Date: 5/6/2009

View of waterward side--pipe and pump visible.

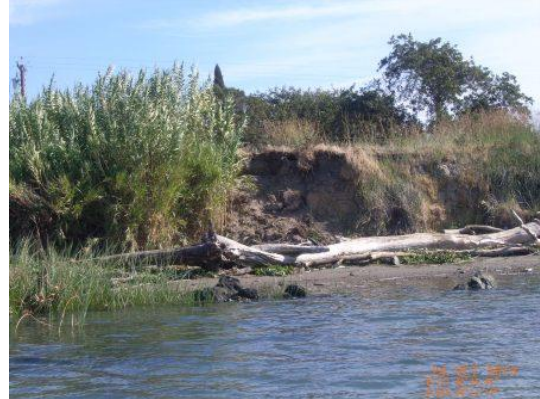
Photo 1 of 1 : SP\_2018\_RD0341\_168\_3\_20180305\_00002.jpg

LM Start	4.47	Rating **	U	Issue No.	3
LM End	4.62	Issue Type +	Ma	Location *	WS
Category	Supplemental			GPS Latitude/Longitude	
				Start	End
Item	2015 USACE Erosion Survey, DRAFT			38.090620 °	38.088572 °
				-121.706684 °	-121.707127 °
DWR ID	DWR_RD0341_02_s_2016_3				
Comment Code					
Inspector Comment					
1999 - New small slump in eroded bank. 2005 - Reach extended because of vertical bank along the roadway upstream. 2011 - More slumping since last year. 2012 - Site upgraded to critical. Very steep slope which may be effecting the highway on top of the levee. 2015: New erosion towards downstream end of site. [2015 Site ID: SAC_8-0_L]

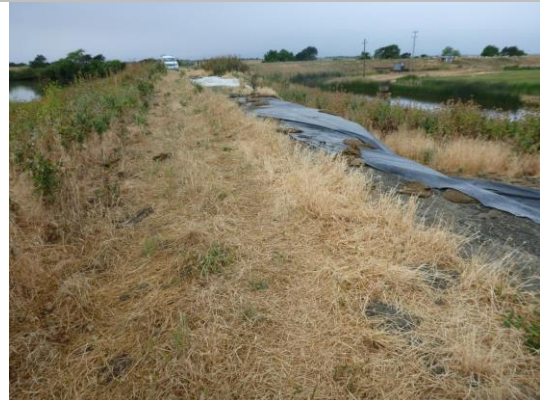
Photo 1 of 3 : SP\_2018\_RD0341\_168\_42\_20180305\_00010.jpg

LM Start	4.75	Rating **	A/W	Issue No.	42
LM End	4.79	Issue Type +	Ma	Location *	
Category	Supplemental			GPS Latitude/Longitude	
				Start	End
Item	2017 Storm Damage			38.086641 °	38.086119 °
				-121.707545 °	-121.707912 °
DWR ID	DWR_RD0341_02_f_2017_42				
Comment Code					
Inspector Comment					
Levee Evaluation Comments					
Description:					
Site ID No:65					
Site Designation:DWR_RD0341_02_s_2012_8					
Repair Type: Erosion					
Rating:Area of Concern					
Field Date:6/8/2017					
Notes: hwy 160 forms levee crown road, erosion has encroached into paved crown, crown 38' wide. This site is currently under contract for repair under FSRP.

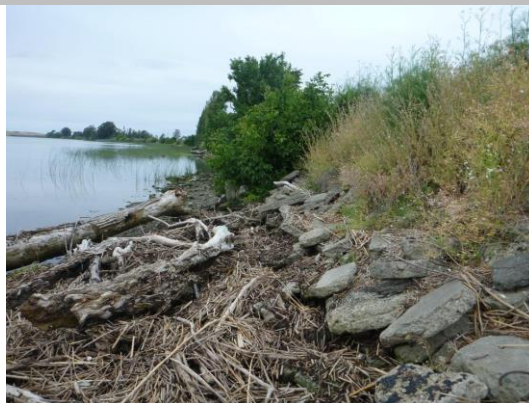
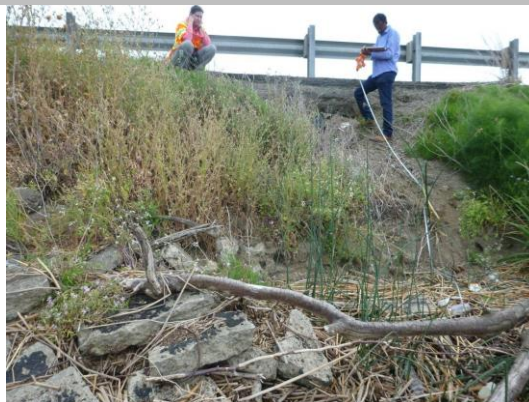
LM Start	4.75	Rating **	A/W	Issue No.	42 (cont)
LM End	4.79	Issue Type +	Ma	Location *	
Category	Supplemental			GPS Latitude/Longitude	
				Start	End
Item	2017 Storm Damage			38.086641 °	38.086119 °
				-121.707545 °	-121.707912 °
DWR ID	DWR_RD0341_02_f_2017_42				
Comment Code					
Inspector Comment					
Levee Evaluation Comments					
Description:					
Site ID No:65					
Site Designation:DWR_RD0341_02_s_2012_8					
Repair Type: Erosion					
Rating:Area of Concern					
Field Date:6/8/2017					
Notes: hwy 160 forms levee crown road, erosion has encroached into paved crown, crown 38' wide. This site is currently under contract for repair under FSRP.

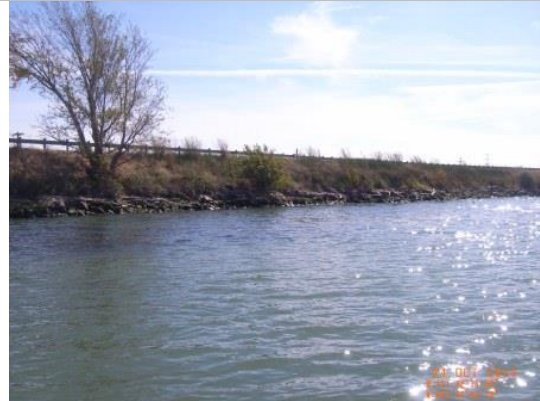
Photo 1 of 1 : SP\_2018\_RD0341\_168\_4\_20180305\_00003.jpg

LM Start	4.76	Rating **	A/W	Issue No.	4
LM End	4.85	Issue Type +	Ma	Location *	WS
Category	Supplemental			GPS Latitude/Longitude	
				Start	End
Item	2015 USACE Erosion Survey, DRAFT			38.086603 °	38.085459 °
				-121.707786 °	-121.708607 °
DWR ID	DWR_RD0341_02_s_2016_4				
Comment Code					
Inspector Comment					
2011 - Large slump section. 2012 - Site extended downstream, upgraded to critical, severe windwave. Slope is very steep and may be effecting the highway on top of the levee. 2015: No observed changes. [2015 Site ID: SAC_7-9_L] 11/02/17: This issue changed from U to A/W due to DWR 2017 Levee Eval Storm Site issue with U rating at same location.

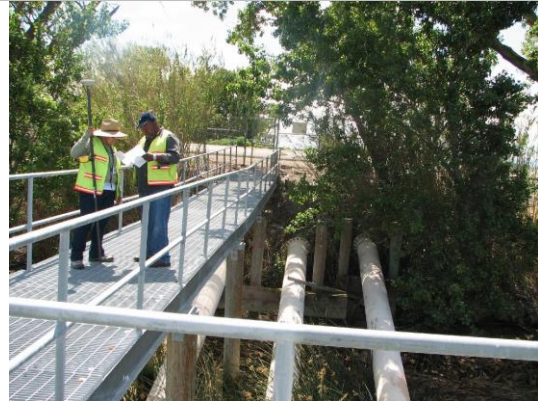
Photo 1 of 3 : UCIP\_SP\_2018\_22253\_37885.jpg

FS\_ID:22253  
DS\_ID:24195  
EP\_NO: 15175  
Repair Type: Non-Urgent  
Crossing Status: Found  
UCIP Comments: Dense vegetation limits the inspector's visibility to identify signs of pipe failure (leaks) along the slope. Recommend removing vegetation along pipe alignment to conduct proper inspection of structure and appurtenances.  
FIELD\_STRUCT\_DESC: [Horseshoe Intake] 1 of 4: 24-inch steel irrigation pipe in 30-inch steel casings through the levee, 6.6 feet below the crown. Annular gap grouted between pipes. Siphon breakers located on the waterside (WS) shoulder, with concrete risers on both ends. Screened inlet manifold (36-inch) with backwash system on pile structure in stream. Surrounded by fence with entry gate. Irrigation pond located on the landside (LS) toe. (three 24-inch pipe authorized under Permit No. 15175, 1993 -Reclamation District 341 [RD0341]; replacement of 210 feet of existing 24-inch pipes, join two pipes at an inlet with a 36-inch screened manifold intake, add bypass valves on both lines, install an access platform, and pressurized backwash system to clean fish screens authorized under Permit No. 16737, 2000 - Department of Water Resources [DWR]) [Additional Reference(s): LMA encroachment station (STA) reference based on Map of Evacuation Route, Reclamation District 341 Sherman Island by Wagner Bonsignore Consulting Civil Engineers, A Corporation dated July 2012, STA 934+00] FS Date: 5/6/2009

Pipes, walkway, fence, and support piles located on waterward side.

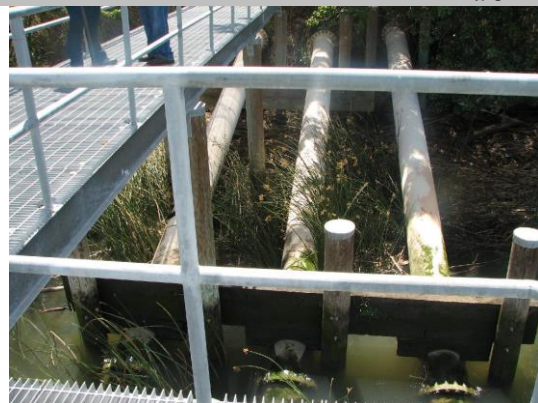
Photo 2 of 3 : UCIP\_SP\_2018\_22253\_37882.jpg

View of waterward side - 3-20 inch pipes.

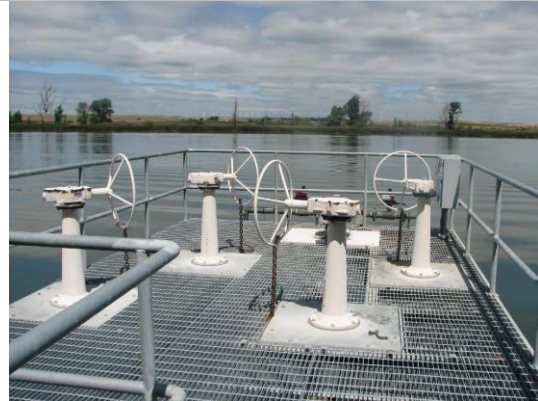
Photo 3 of 3 : UCIP\_SP\_2018\_22253\_37881.jpg

Comment Code					
Inspector Comment					
FS_ID:22253 DS_ID:24195 EP_NO: 15175 Repair Type: Non-Urgent Crossing Status: Found UCIP Comments: Dense vegetation limits the inspector's visibility to identify signs of pipe failure (leaks) along the slope. Recommend removing vegetation along pipe alignment to conduct proper inspection of structure and appurtenances. FIELD_STRUCT_DESC: [Horseshoe Intake] 1 of 4: 24-inch steel irrigation pipe in 30-inch steel casings through the levee, 6.6 feet below the crown. Annular gap grouted between pipes. Siphon breakers located on the waterside (WS) shoulder, with concrete risers on both ends. Screened inlet manifold (36-inch) with backwash system on pile structure in stream. Surrounded by fence with entry gate. Irrigation pond located on the landside (LS) toe. (three 24-inch pipe authorized under Permit No. 15175, 1993 -Reclamation District 341 [RD0341]; replacement of 210 feet of existing 24-inch pipes, join two pipes at an inlet with a 36-inch screened manifold intake, add bypass valves on both lines, install an access platform, and pressurized backwash system to clean fish screens authorized under Permit No. 16737, 2000 - Department of Water Resources [DWR]) [Additional Reference(s): LMA encroachment station (STA) reference based on Map of Evacuation Route, Reclamation District 341 Sherman Island by Wagner Bonsignore Consulting Civil Engineers, A Corporation dated July 2012, STA 934+00] FS Date: 5/6/2009

Gates located on waterward side.

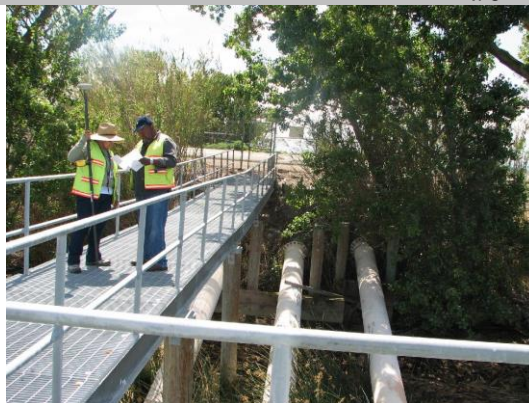
Photo 1 of 3 : UCIP\_SP\_2018\_22254\_37896.jpg

FS\_ID:22254  
DS\_ID:24239  
EP\_NO: 15175  
Repair Type: Non-Urgent  
Crossing Status: Found  
UCIP Comments: Dense vegetation limits the inspector's visibility to identify signs of pipe failure (leaks) along the slope. Recommend removing vegetation along pipe alignment to conduct proper inspection of structure and appurtenances.  
FIELD\_STRUCT\_DESC: [Horseshoe Intake] 2 of 4: 24-inch steel irrigation pipe in 30-inch steel casings through the levee, 6.6 feet below the crown. Annular gap grouted between pipes. Siphon breakers located on the waterside (WS) shoulder, with concrete risers on both ends. Screened inlet manifold (36-inch) with backwash system on pile structure in stream. Surrounded by fence with entry gate. Irrigation pond is located on the landside (LS) toe. (three 24-inch pipe authorized under Permit No. 15175, 1993 -Reclamation District 341 [RD0341]; replacement of 210 feet of existing 24-inch pipes, join two pipes at an inlet with a 36-inch screened manifold intake, add bypass valves on both lines, install an access platform, and pressurized backwash system to clean fish screens authorized under Permit No. 16737, 2000 - Department of Water Resources [DWR]) [Additional Reference(s): LMA encroachment station (STA) reference based on Map of Evacuation Route, Reclamation District 341 Sherman Island by Wagner Bonsignore Consulting Civil Engineers, A Corporation dated July 2012, STA 934+00] FS Date: 5/6/2009

Pipes, walkway, fence, and support piles located on waterward side.

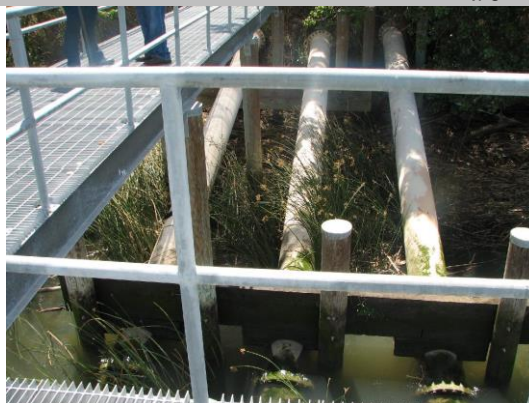
Photo 2 of 3 : UCIP\_SP\_2018\_22254\_37898.jpg

View of waterward side - 3-20 inch pipes.

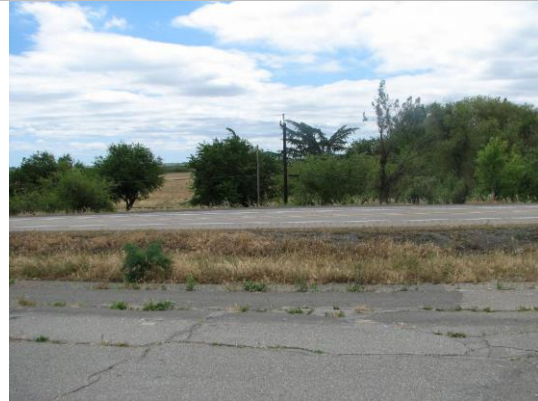
Photo 1 of 3 : UCIP\_SP\_2018\_22256\_37915.jpg

FS\_ID:22256  
DS\_ID:24127  
EP\_NO: 11116  
Repair Type: Non-Urgent  
Crossing Status: Found  
UCIP Comments: Need to coordinate with owner to determine status of crossing. If crossing is no longer in use owner will need to contact the CVFPB to comply with Title 23. Dense vegetation limits the inspector's visibility to identify signs of pipe failure (leaks) along the slope. Recommend removing vegetation along pipe alignment to conduct proper inspection of structure and appurtenances.  
FIELD\_STRUCT\_DESC: 16-inch steel irrigation pipe sleeved through 18-inch pipe through the levee, 2.5 feet below the crown. Annular gap grouted. Air vent on waterside (WS). (16-inch sleeved through 18-inch pipe authorized under Automatic Board Order (ABO) issued as Permit No. 11116, 1975 - C. E. & J. E. Upham; widen and realign State HWY 160 and extend three irrigation pipes authorized under Permit No. 15372, 1993 - Department of Transportation [Caltrans]) [Additional Reference(s): DWR Levee Log, 1992. USACE Sacramento O&M Manual Unit No. 101, February 1962, (HLM 5.40). LMA encroachment station (STA) reference based on Map of Evacuation Route, Reclamation District 341 Sherman Island by Wagner Bonsignore Consulting Civil Engineers, A Corporation dated July 2012, STA 917+00]

Overview of levee crown at crossing.

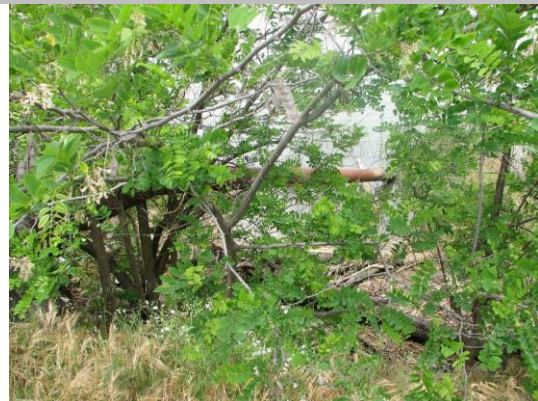
Photo 2 of 3 : UCIP\_SP\_2018\_22256\_37914.jpg

View of pipe through brush on waterward side.

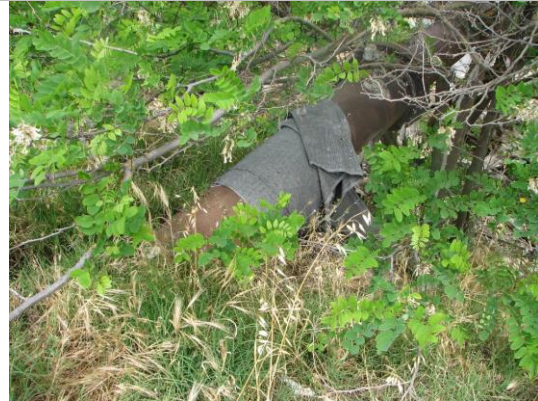
Photo 3 of 3 : UCIP\_SP\_2018\_22256\_37917.jpg

Comment Code						
Inspector Comment						
FS_ID:22256 DS_ID:24127 EP_NO: 11116 Repair Type: Non-Urgent Crossing Status: Found UCIP Comments: Need to coordinate with owner to determine status of crossing. If crossing is no longer in use owner will need to contact the CVFPB to comply with Title 23. Dense vegetation limits the inspector's visibility to identify signs of pipe failure (leaks) along the slope. Recommend removing vegetation along pipe alignment to conduct proper inspection of structure and appurtenances. FIELD_STRUCT_DESC: 16-inch steel irrigation pipe sleeved through 18-inch pipe through the levee, 2.5 feet below the crown. Annular gap grouted. Air vent on waterside (WS). (16-inch sleeved through 18-inch pipe authorized under Automatic Board Order (ABO) issued as Permit No. 11116, 1975 - C. E. & J. E. Upham; widen and realign State HWY 160 and extend three irrigation pipes authorized under Permit No. 15372, 1993 - Department of Transportation [Caltrans]) [Additional Reference(s): DWR Levee Log, 1992. USACE Sacramento O&M Manual Unit No. 101, February 1962, (HLM 5.40). LMA encroachment station (STA) reference based on Map of Evacuation Route, Reclamation District 341 Sherman Island by Wagner Bonsignore Consulting Civil Engineers, A Corporation dated July 2012, STA 917+00] FS Date: 5/6/2009

Pipe on waterward side at daylight.

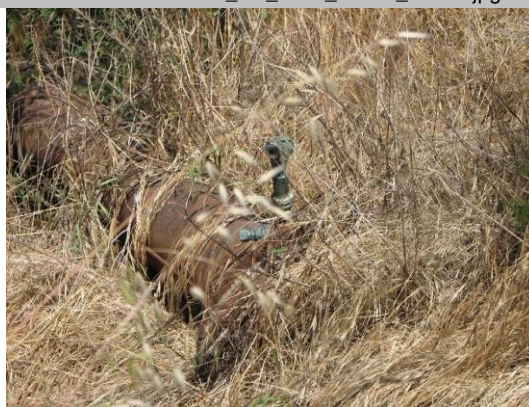
Photo 2 of 3 : UCIP\_SP\_2018\_22258\_37930.jpg

Air vent located on waterward side.

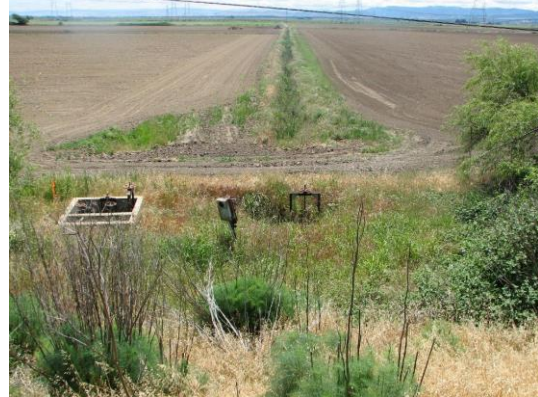
Photo 3 of 3 : UCIP\_SP\_2018\_22258\_37931.jpg

Comment Code						
Inspector Comment						
FS_ID:22258 DS_ID:24074 EP_NO: 11116 Repair Type: Non-Urgent Crossing Status: Found UCIP Comments: Dense vegetation limits the inspector's visibility to identify signs of pipe failure (leaks) along the slope. Recommend removing vegetation along pipe alignment to conduct proper inspection of structure and appurtenances. FIELD_STRUCT_DESC: 1 of 2: 8-inch steel irrigation pipe sleeved through 10-inch pipe through levee, 2.5 feet below the crown. Annular gap grouted. Concrete distribution box with slide gate located on the landside (LS) toe. Air vent located on the waterside (WS). (8-inch sleeved through 10-inch pipe authorized under Automatic Board Order (ABO) issued as Permit No. 11116, 1975 - C. E. & J. E. Upham; distribution box installed and pipe along LS slope removed and replaced with longer 10-inch steel pipe authorized under Permit No. 15372, 1993 - Department of Transportation [Caltrans]) [Additional Reference(s): DWR Levee Log, 1992. USACE Sacramento O&M Manual Unit No. 101, February 1962, (HLM 5.81). LMA encroachment station (STA) reference based on Map of Evacuation Route, Reclamation District 341 Sherman Island by Wagner Bonsignore Consulting Civil Engineers, A Corporation dated July 2012, STA 891+00] FS Date: 5/6/2009

View of landward side.

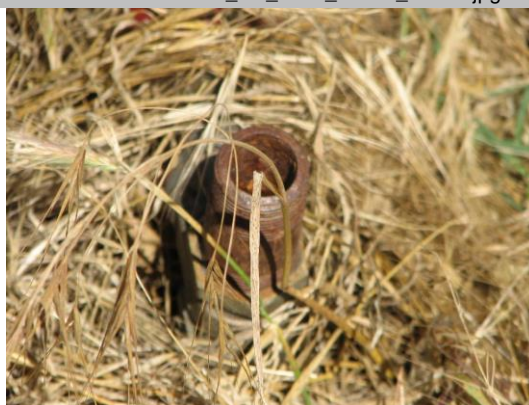
Photo 2 of 3 : UCIP\_SP\_2018\_22259\_37936.jpg

View of pipes on waterward side.

Air vent located on waterward side.

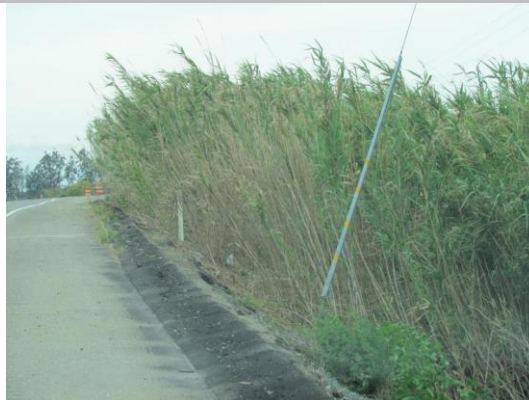
Photo 1 of 1 : SP\_2018\_RD0341\_168\_49\_20180305\_00015.jpg

LM Start	6.03	Rating **	U	Issue No.	49
LM End	6.10	Issue Type +	Ma	Location *	LS
Category	Earthen Levee			GPS Latitude/Longitude	
				Start	End
Item	Vegetation			38.080143 °	38.080125 °
				-121.728332 °	-121.729662 °
DWR ID	DWR_RD0341_02_f_2016_49				
Comment Code					
V2 : Remove the wild growth other than native grasses from the levee slopes.					
Inspector Comment					
Remove the bamboo from the landside levee slope.

RD 341 Landside slope from levee mile 6.03-6.10 tall unwanted growth of Arundo present on the levee section.

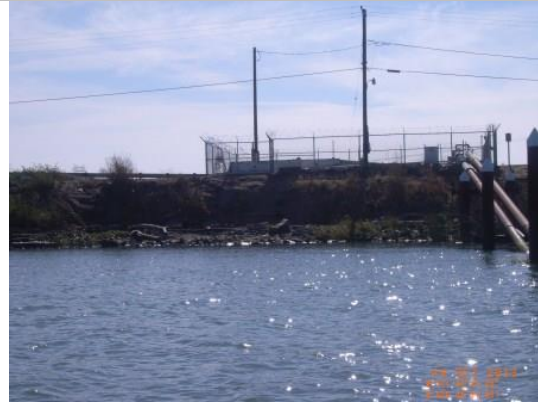
Photo 1 of 1 : SP\_2018\_RD0341\_168\_1\_20180305\_00001.jpg

LM Start	6.03	Rating **	U	Issue No.	1
LM End	6.16	Issue Type +	Ma	Location *	WS
Category	Supplemental			GPS Latitude/Longitude	
				Start	End
Item	2015 USACE Erosion Survey, DRAFT			38.080370 °	38.080526 °
				-121.728341 °	-121.730483 °
DWR ID	DWR_RD0341_02_s_2016_1				
Comment Code					
Inspector Comment					
2011 - Large slump at downstream end. Gully formed from surface runoff from the road. Shallow slumping throughout site. 2012 - The gully at upstream end has increased in size and site continues to worsen. 2015: No observed changes. [2015 Site ID: SAC_7-3_L]

USACE 2013 Photo #1

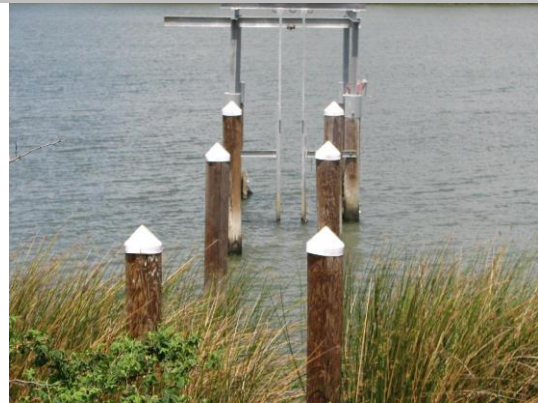
Photo 1 of 3 : UCIP\_SP\_2018\_39861\_71853.jpg

Comment Code						
Inspector Comment						
FS_ID:39861 DS_ID:24076 EP_NO: 11116 Repair Type: Non-Urgent Crossing Status: Found UCIP Comments: Need to contact owner to determine status of crossing. If crossing is no longer used will need to meet Title 23 requirements. Hole present in pipe section. Debris on waterward side--10-inch pipe section abandoned on slope. Dense vegetation limits the inspector's visibility to identify signs of pipe failure (leaks) along the slope. Recommend removing vegetation along pipe alignment to conduct proper inspection of structure and appurtenances. FIELD_STRUCT_DESC: 12-inch steel irrigation pipe sleeved through 14-inch pipe through levee, 4.0 feet below crown. Annular gap grouted. Slide gate in distribution box on landside (LS). (12-inch sleeved though 14-inch pipe authorized under Automatic Board Order (ABO) issued as Permit No. 11116, 1975 - C. E. & J. E. Upham; widen and realign State HWY 160 and extend three irrigation pipes authorized under Permit No. 15372, 1993 - Department of Transportation [Caltrans]) [Additional Reference(s): DWR Levee Log, 1992. USACE Sacramento O&M Manual Unit No. 101, February 1962, (HLM 6.12). LMA encroachment station (STA) reference based on Map of Evacuation Route, Reclamation District 341 Sherman Island by Wagner Bonsignore Consulting Civil Engineers, A Corporation dated July 2012, STA 874+00] FS Date: 5/6/2009

View of structure located on waterward side.

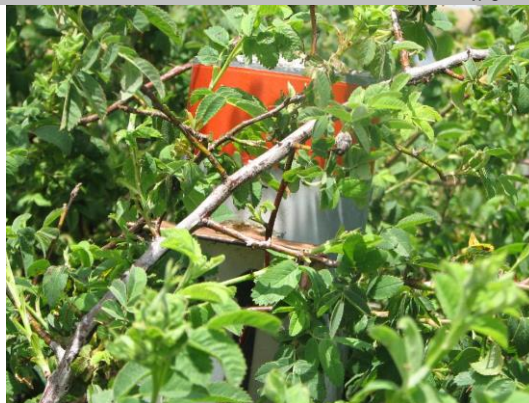
Photo 2 of 3 : UCIP\_SP\_2018\_39861\_71852.jpg

Marker visible on waterward side associated with crossing.

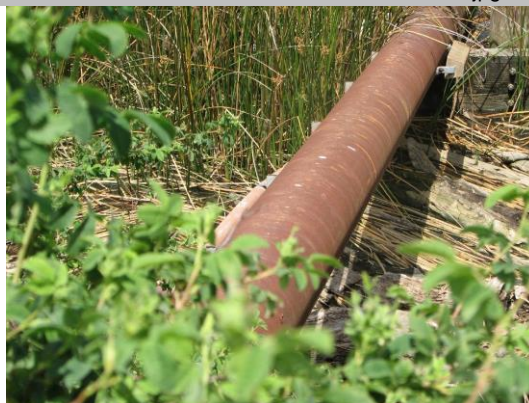
Photo 3 of 3 : UCIP\_SP\_2018\_39861\_71851.jpg

Pipe section visible on waterward side.

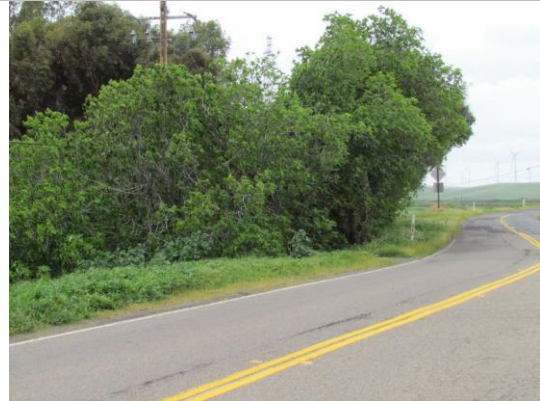
Photo 1 of 1 : SP\_2018\_RD0341\_168\_47\_20180305\_00014.jpg

RD 341 landside levee slope mile 6.29-6.32.

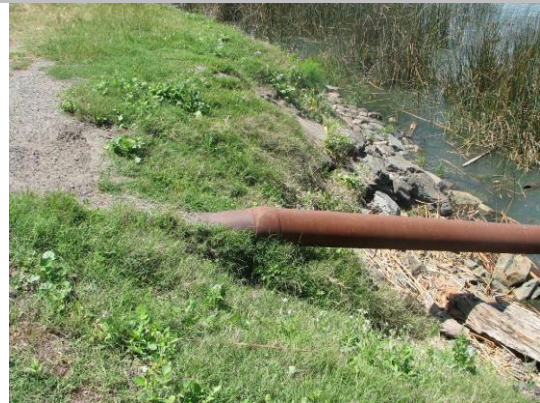
Photo 1 of 3 : UCIP\_SP\_2018\_22261\_37949.jpg

Side view of pipe on waterward side.

FS\_ID:22261  
DS\_ID:24078  
EP\_NO: 11116  
Repair Type: Non-Urgent  
Crossing Status: Found  
UCIP Comments: Dense vegetation limits the inspector's visibility to identify signs of pipe failure (leaks) along the slope. Recommend removing vegetation along pipe alignment to conduct proper inspection of structure and appurtenances.  
FIELD\_STRUCT\_DESC: 12-inch steel pipe of unknown purpose through the levee, 2 feet below the crown. Siphon breaker on landside (LS) slope. Rock revetment on waterside (WS) slope. (12-inch authorized under Automatic Board Order (ABO) issued as Permit No. 11116, 1975 - C. E. & J. E. Upham) [Additional Reference(s): DWR Levee Log, 1992. USACE Sacramento O&M Manual Unit No. 101, February 1962, (HLM 6.30). LMA encroachment station (STA) reference based on Map of Evacuation Route, Reclamation District 341 Sherman Island by Wagner Bonsignore Consulting Civil Engineers, A Corporation dated July 2012, STA 857+00]

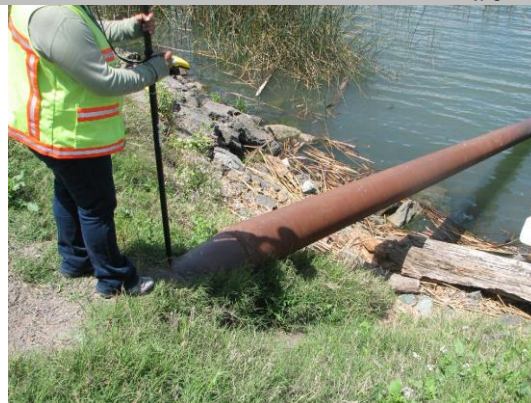
Photo 2 of 3 : UCIP\_SP\_2018\_22261\_37947.jpg

View of pipe and rip rap on waterward side.

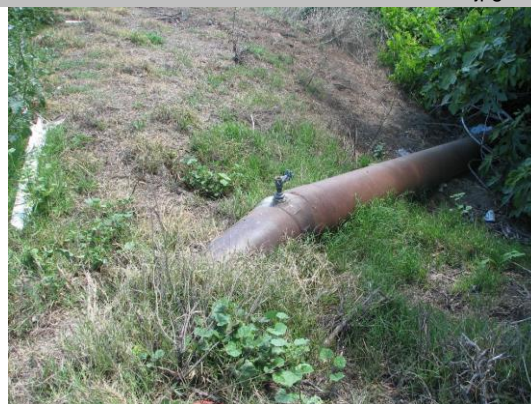
Photo 3 of 3 : UCIP\_SP\_2018\_22261\_37948.jpg

View of crossing on landward slope.

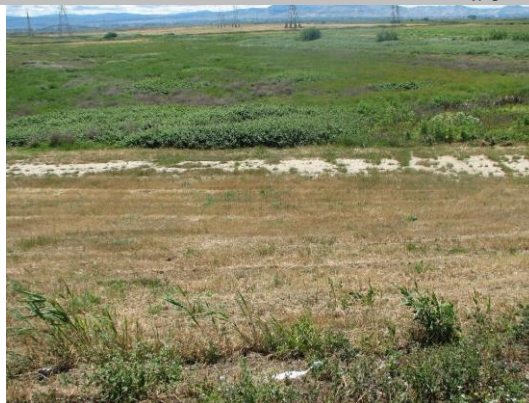
Photo 1 of 2 : UCIP\_SP\_2018\_22262\_37953.jpg

Comment Code						
Inspector Comment						
FS_ID:22262 DS_ID:24079 EP_NO: 11107 Repair Type: Non-Urgent Crossing Status: Indicator Found UCIP Comments: Need to contact owner to determine status of crossing. If crossing is no longer in used owner will need to comply with Title 23. Dense vegetation limits the inspector's visibility to identify signs of pipe failure (leaks) along the slope. Recommend removing vegetation along pipe alignment to conduct proper inspection of structure and appurtenances. FIELD_STRUCT_DESC: 4-inch steel pipe type unknown through the levee, 4 feet below the crown. (4-inch pipe authorized under Permit No. 11107, 1975 - G. Celli) [Additional Reference(s): DWR Levee Log, 1992. LMA encroachment station (STA) reference based on Map of Evacuation Route, Reclamation District 341 Sherman Island by Wagner Bonsignore Consulting Civil Engineers, A Corporation dated July 2012, STA 851+00] FS Date: 5/6/2009

View of landward side no evidence of crossing.
